Active Errata List

CAN Microcontrollers

T89C51CC01
T89C51CC01UA
T89C51CC01CA

Errata Sheet

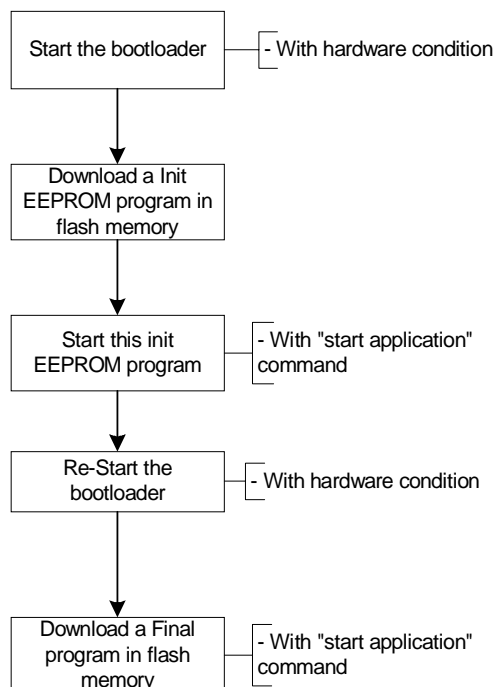
16. EEPROM – Lock-up during ISP write.

Program lock-up can be experienced when using Atmel FLIP software or a custom In system Programming tools to write in the internal EEPROM. This problem occurs with clock frequency > 12MHz in X2 mode or 24MHz in X1 mode. Neither the code Flash nor the EEPROM are corrupted by the lock-up. Although the EEPROM cannot be written by the bootloader.

This problem is bootloader related and doesn't affect the capability for the user to read and write into the EEPROM. This problem is technology dependant. The likelihood of experiencing the problem is low at Clock frequency > 24 MHz in X1 mode and nulle below. A reset can be applied to recover from the lock-up.

The following process can be done to work around the problem.

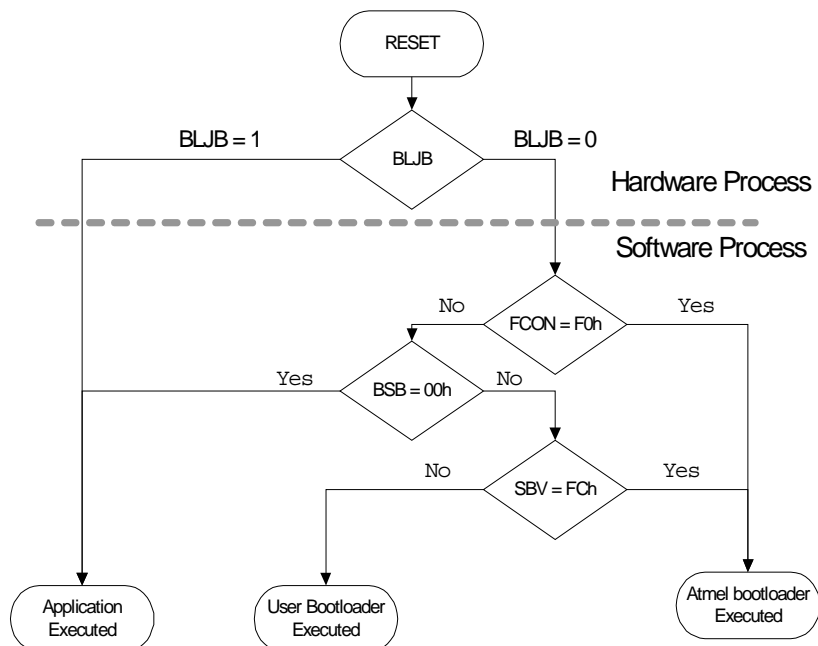
Version 1.2:

4. Boot Process Compatibility

There are some differences between Boot process of bootloader 1.2 and newer versions (see below).

Use the fuse bit BLJB to start the application in both versions.
