Corrections of Hardware Manual

MB90495

hm90495-cm44-10114-3e-x1-01

Addendum, MB90495G Hardware Manual (hm90495-cm44-10114-3e)

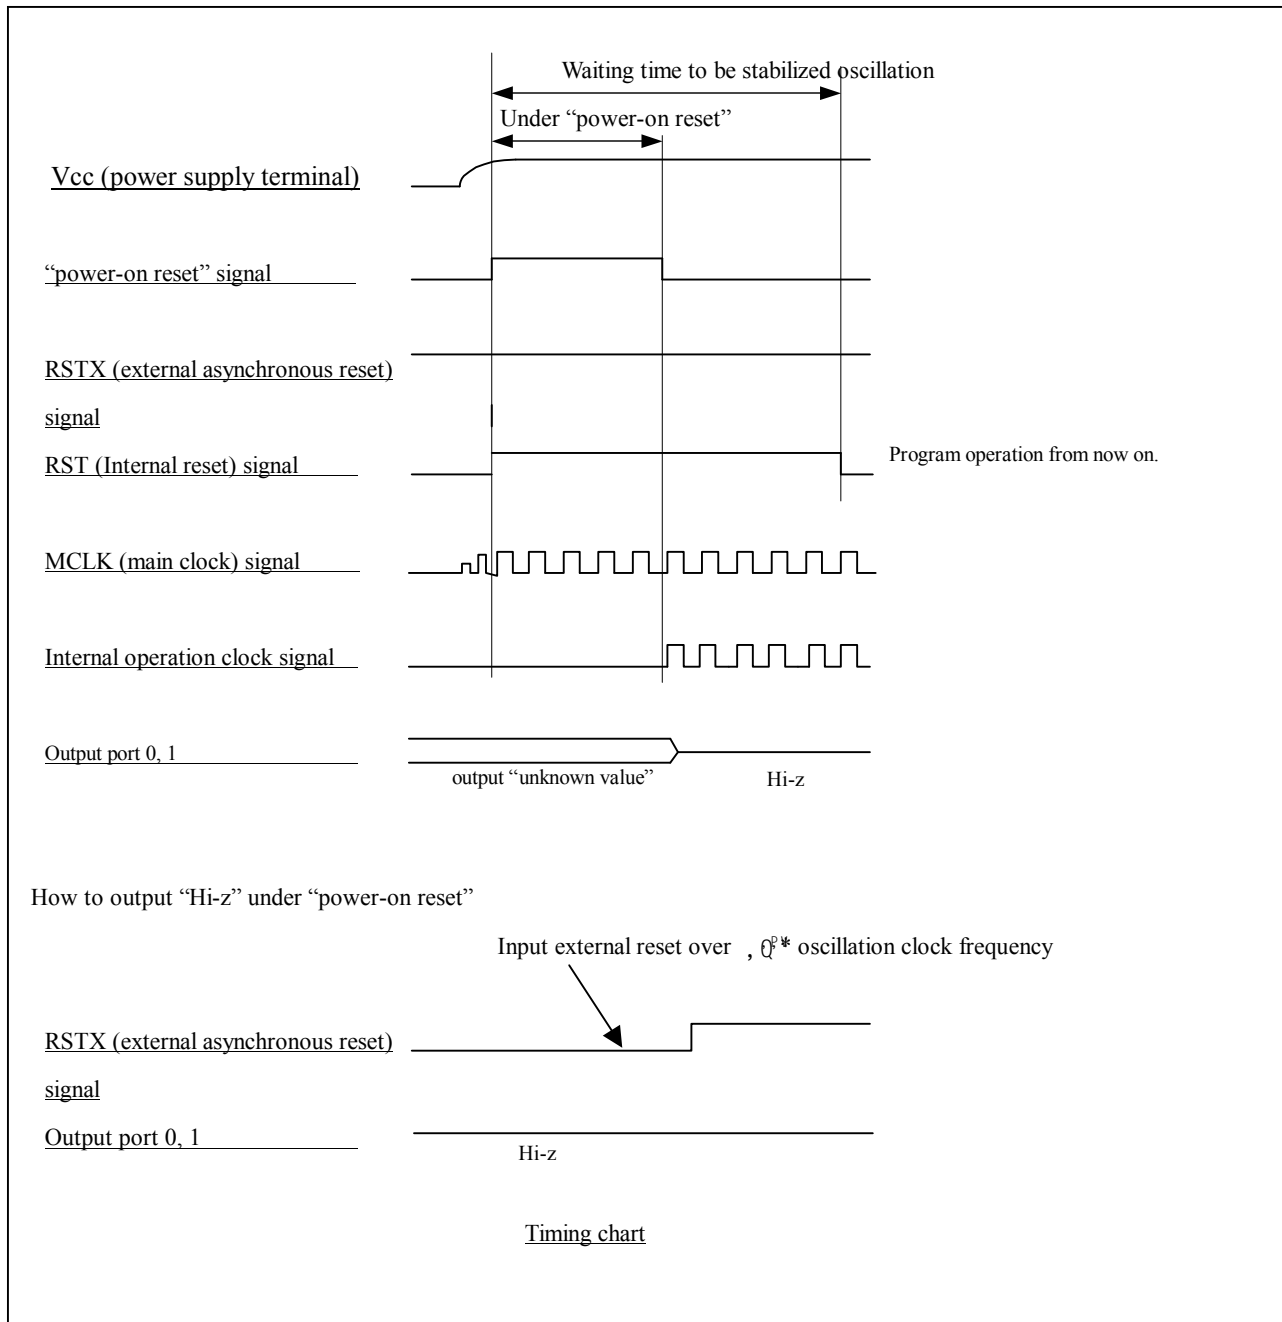
Pin 00 to pin 07 and pin 10 to pin 17 terminal become "unknown value" (output "H", "L" level or output "Hi-z") under "power-on reset" (stabilized times (2^{\square} * oscillation clock frequency) of clamping circuit for internal power supply), when the power supply is turned on, and when "power-on reset" function operates and RSTX terminal is "H" level.

If you want to output "Hi-z" under "power-on reset", it is applied reset input "L" level " from external and so pin 00 to pin 07 and pin 10 to pin 17 terminal become "Hi-z" condition during the time.

Following Ports will drive a Level: P30='L' and P31='H' and cannot be set to High-Z by asserting RST.

Under "power-on reset" 2^{17} * oscillation clock frequency
(8.192ms in case of oscillation clock frequency = 16MHz)

Waiting time to be stabilized oscillation 2^{17} * oscillation clock frequency
(16.384ms in case of oscillation clock frequency = 16MHz)

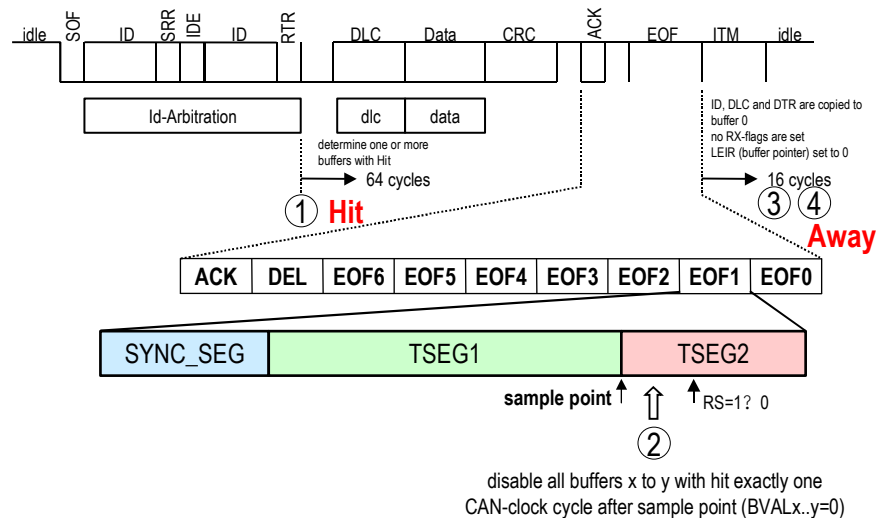
If there is a complete (no error until 6th bit of EOF) incoming message that have passed the acceptance filter, then this message is stored into a message buffer x (with x=0...15). If this store operation coincides with reset operation of the corresponding BVAL bit (BVALx=0), the received message will be stored into the message buffer 0 regardless of register settings. Note that this coincidence has to happen within a specific CAN-clock cycle (see event 2 in figures). Hence, the probability is very low.

When disabling message buffers by the BVAL register, it must be avoided that the write operation to the BVAL register coincides with the store operation of the received message in the CAN Controller.

The following diagram illustrates the timing to be avoided for the BVAL write operation.

- ① CAN-controller determines buffers, which can store the message, because their acceptance filters had been passed.
- ② Software disable all buffers with hit exactly one CAN-clock cycle after the sample point of EOF1.
- ③ CAN-controller stores received ID, DLC and data in buffer 0 regardless of the buffers determined in ①.
- ④ CAN-Controller sets LEIR to point to buffer 0 but RX-flags (RCR, ROVR, RRTRR) are not set.
- ④

Write 1 to the HALT bit and read it back for checking the result is 1. Then change settings for the ID/AMS/AMR0/1 registers.

Do not use the message buffer 0. In other words, disable message buffer (BVAL=0), prohibit receive interrupt (RIE=0) and do not request transmission (TREQ=0).

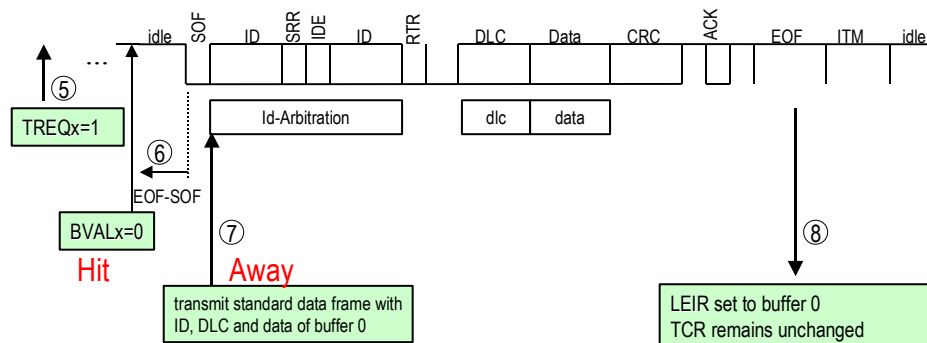
When there is a pending transmission of buffer x and the CAN bus status is in Intermission or in Bus Idle, the CAN-controller will load the message from buffer x in order to send it. If this load operation coincides with disabling the pending message buffer x by clearing the BVAL bit, this results in transmission of a Standard message. This message consists of RTR=0, IDE=0, DLC, 11 ID bits and Data stored in the message buffer 0. Note that this coincidence has to happen with in a specific CAN-clock cycle. Hence, the probability is very low. The position of that cycle depends also on previous frame reception and occurrence of error frames.

When disabling message buffers by the BVAL register, it must be avoided that the write operation to the BVAL register coincides with the preparation for the next transmission in the CAN Controller.

The following diagram illustrates the timing to be avoided for the BVAL write operation.

- ⑤ Software requests transmission of buffer x by setting TREQx.
- ⑥ Software disables the buffer x by clearing BVALx.
- ⑦ CAN-controller transmits a standard data frame with ID, length code and data of buffer 0.
- ⑧ After completion of frame only LEIR is updated for buffer 0. However, TCR is not set (neither for buffer 0 nor for buffer x).

Do not use the BVAL bit for suppressing/cancellation of transmission request. The TCANR bit is prepared for this purpose.

4. Wait for completion of transmission.
A buffer must not be disabled by clearing the BVAL-flag, as long as there is a pending transmission. Easiest way to wait for transmission completion is to use transmission interrupt but polling of TREQ is also possible.
